Restoring Wilshire Boulevard Temple

Wilshire Boulevard Temple: Storied Past, Bright Future

The original building's restoration and renovation spanned two years, from September 2011 to September 2013. It cost \$47.5 million and required many specialists.

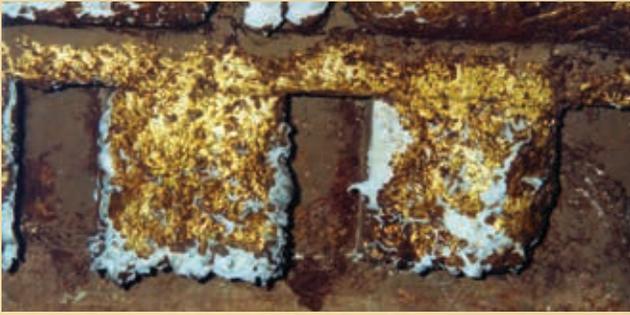
Prior to restoration, decorative plaster in the sanctuary was covered in a powdery efflorescence due to water and humidity damage. Photo courtesy of Simpson Gumpertz & Heger.

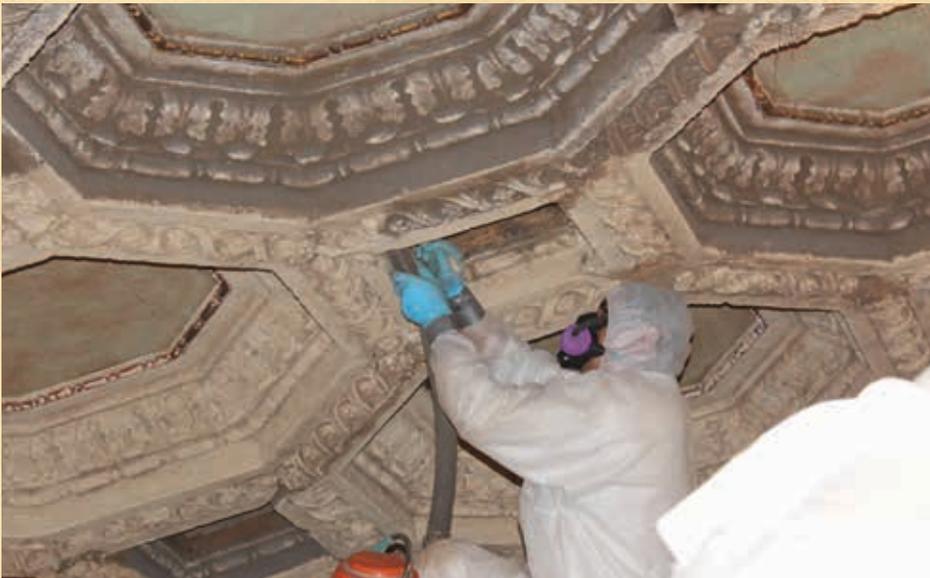
Each octagonal coffer on the dome was covered with over 80 years of built-up dirt and had to be carefully hand-vacuumed. Photo courtesy of Wilshire Boulevard Temple.

octagons and soaring 110 feet above the sanctuary floor. The inner dome had deteriorated from water damage and high humidity, which caused efflorescence (a powdery substance) to form on some of the plaster, crack, and even break off in some places. The octagonal coffers were also covered in layers of brown dirt, dimming the original colors and decorative shapes. The gilded plaster throughout the sanctuary had oxidized, turning its original gold leaf into a brown color.

The restoration team built two enormous scaffold platforms, one rising fifty feet and the other a hundred feet. Every coffer was vacuumed, loose areas were stabilized, and new plaster castings were made to replace deteriorated or lost pieces. Historic documentation allowed the architects to replicate the original paint, glaze, and gold-leaf colors. The prayer inscribed in gold around the oculus at the apex of the dome is once again vibrant: Sh'ma Yisrael, Adonai Eloheinu, Adonai Echad ("Hear O Israel, the Lord Our God, the Lord Is One").

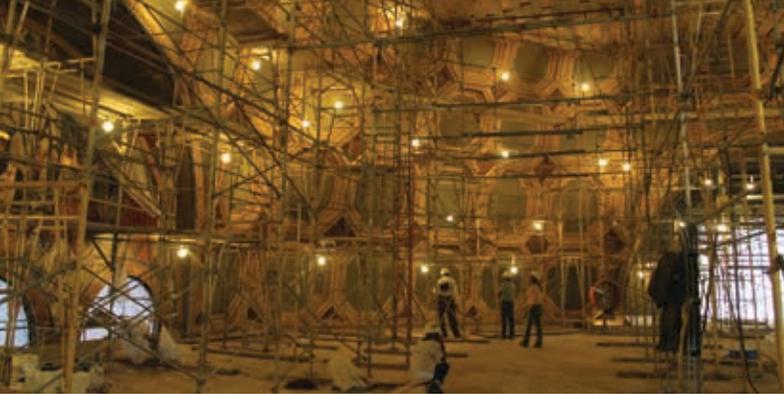
Scaffold platforms enabled the restoration team to work high above the sanctuary floor. Photo courtesy of Levin & Associates Architects.

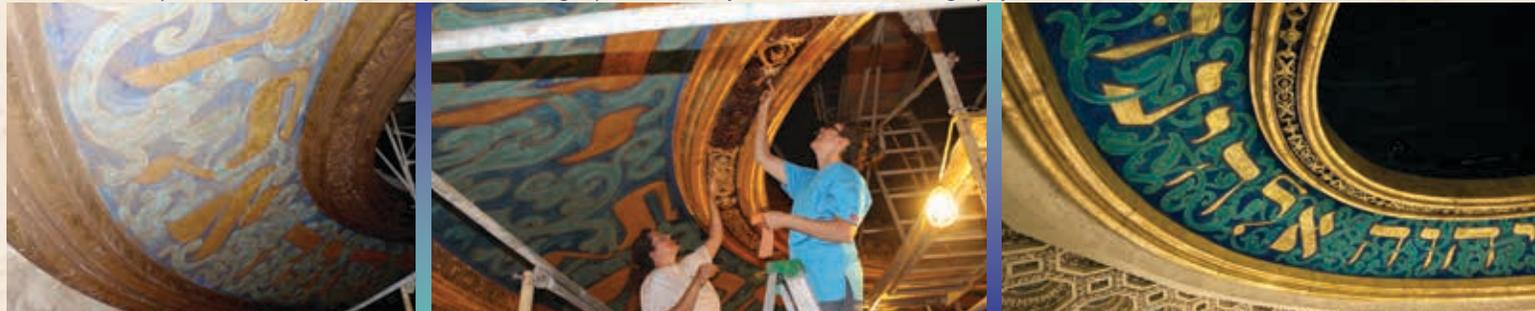
Careful restoration allowed the bright colors and gold leafing around the oculus to once again be vibrant. Left and middle photos courtesy of MATT Construction. Right photo courtesy of Tom Bonner Photography.

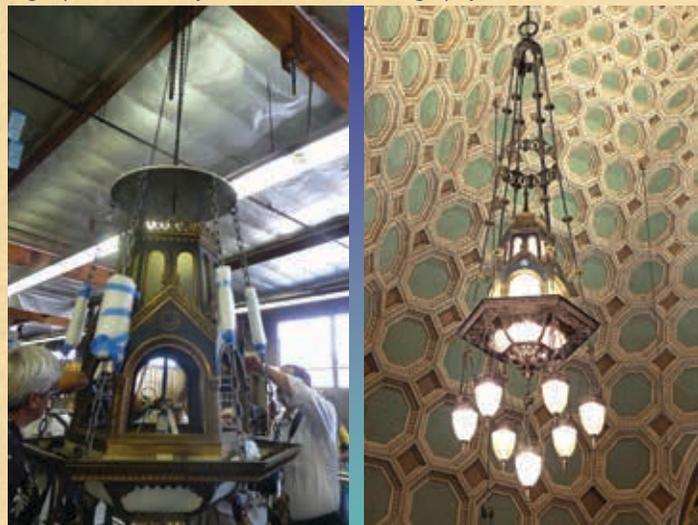
Members of the restoration team removed the eight Spice Box Chandeliers to clean and repair them before rehanging.

Eight chandeliers hang from the ceiling of the sanctuary. They are known as the Spice Box Chandeliers because they were patterned after the spice boxes used in the Havdalah service that ends the Sabbath. To restore them, the project team lowered each one from the ceiling using a winch. New LED lights were added to the base ring to illuminate the beads and chain. To augment their beautiful yet insufficient light, eight new light niches with theatrical lighting were added to the sanctuary walls, each concealed by a gold metal grille.

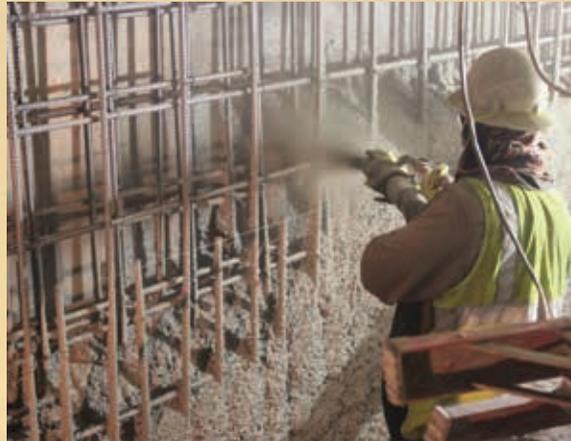
One of the most challenging aspects of the restoration was seismically retrofitting the sanctuary without changing its appearance. Even though previous seismic surveys had confirmed that the concrete dome had survived previous earthquakes with virtually no structural damage, computer modeling indicated the potential failure of the sanctuary's four diagonal walls.

A member of the restoration team sprayed concrete through a hose at high velocity onto new shear walls as part of the seismic retrofit of the sanctuary. Photo courtesy of Wilshire Boulevard Temple.

The solution was to insert shear walls, designed to resist the lateral force of an earthquake, within the existing walls. This invisible approach would strengthen the building without affecting its historic features. However, nearly every surface in the sanctuary is covered in historic decoration. The project team chose for the point of entry the corridor walls that were the least embellished, and where the historic fabric could most easily be removed and replaced or, if necessary, recreated.

New footings were dug ten feet below the basement. A matrix of steel filled with shotcrete (concrete shot through a hose at a high velocity onto a surface) was built from the basement to the top of the dome, a height equivalent to five stories. After the shear walls were installed, the corridor plaster walls were replaced and refinished to match the

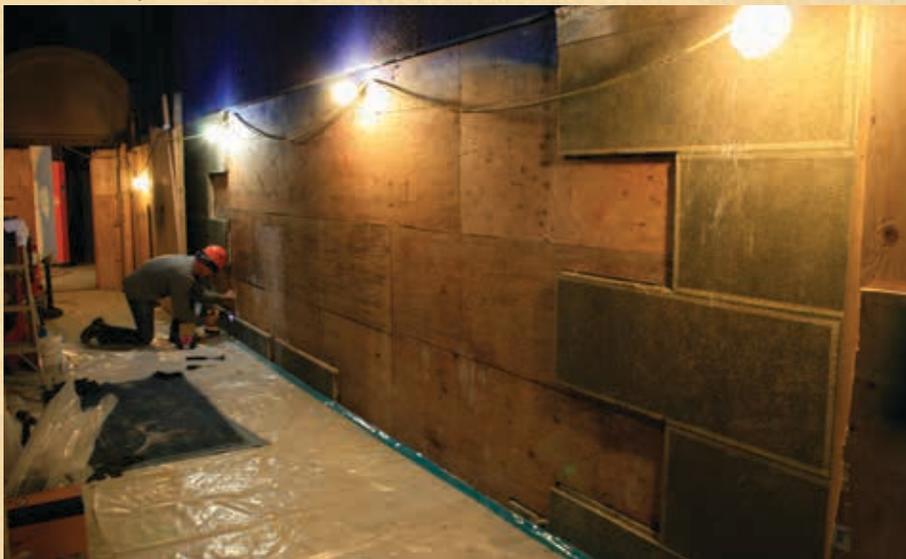
Sections of the green Zenitherm tiles that lined the hallways were removed as part of the seismic retrofit and had to be recreated and installed.

original surfaces, including recreating some of the Zenitherm finish that resembles green mortared stone. Zenitherm is a composite material made to look like stone but cut like wood; it was often used for decorative

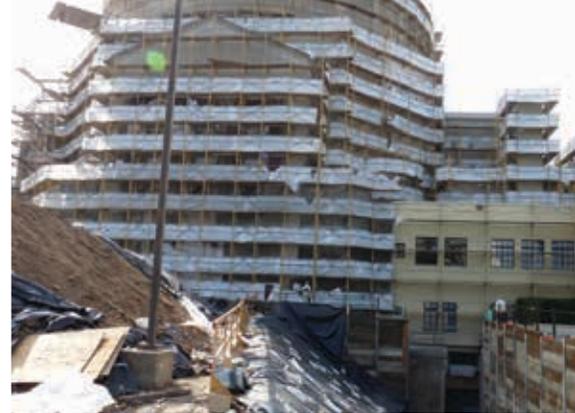
To repair exterior damage, scaffolding was erected all around the Temple and the parking lot was dug up to allow access to the basement to install the new HVAC system. Photo courtesy of Levin & Associates Architects.

The exterior of the original building was stripped of its yellowing paint, exposing cracks and chips that had to be repaired before a new coating could be applied. The black Belgian marble bands that wrapped the base of the building had turned gray due to calcification. Unfortunately beyond repair, the marble was replaced with Virginia Mist granite, which has a color similar to the original dark black.

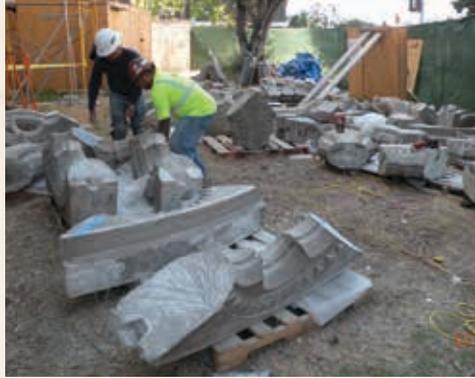
The windows were some of the most vulnerable elements of the building. Eighty years of deterioration led to the loosening, cracking, and bowing of glass and stone, which had the potentially great risk of falling. Proper restoration of the rose window and west tripartite windows required that they be totally dismantled and the art glass removed.

Members of the restoration team examined pieces of the stone casting that surrounded the Rose Window after it was removed for repair. Photo courtesy of Levin & Associates Architects.

patched. A structural reinforcement plan required that sections of stone be cut and grooved, so that a continuous stainless steel ring could be placed in both the outer and inner circle of cast stone. The two circles of cast stone, connected by stone spokes, were reinforced by drilling stainless steel dowels through the spokes.

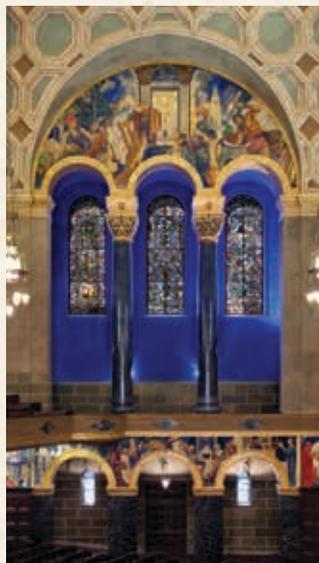
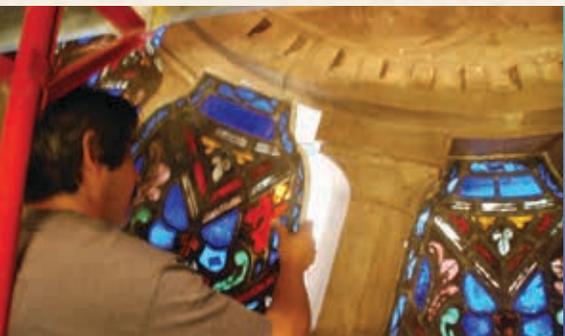
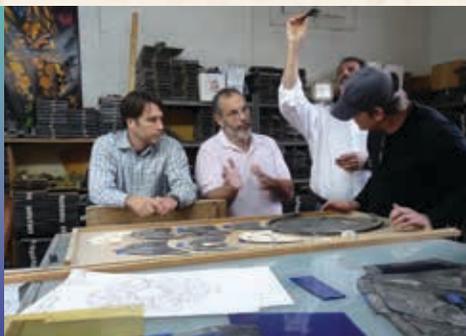
Above: The restored west tripartite window. Photo courtesy of Tom Bonner Photography. **Below: Sections of the windows were carefully removed, inventoried, documented, cleaned, and repaired.** Left photo courtesy of Judson Studios. Right photo courtesy of Levin & Associates Architects.

Working from a thirty-five-foot scaffold, conservators carefully removed the panels and transported them to their studios. The panels were documented, cleaned, and re-leaded before re-installation. When replacement of glass was required, new glass was selected to match the original.

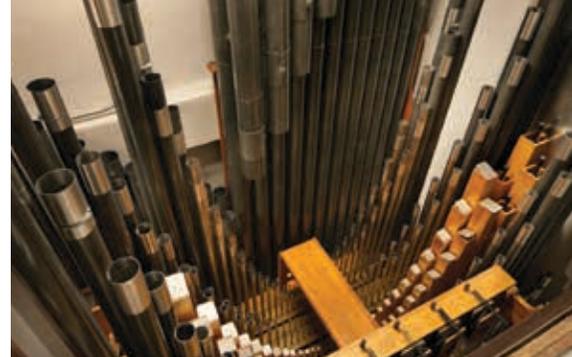
It took two 18-wheeler trucks to ship over 4,000 organ pipes and the console to Ohio for restoration. Photo courtesy of Tom Bonner Photography.

The organ was completely refurbished by the Shantz Organ Company in Ohio. All the pipes and the console were shipped to Ohio, where they were cleaned and restored. The parts were shipped back over the summer of 2013 and reinstalled by a team of technicians from Shantz over a period of four weeks.

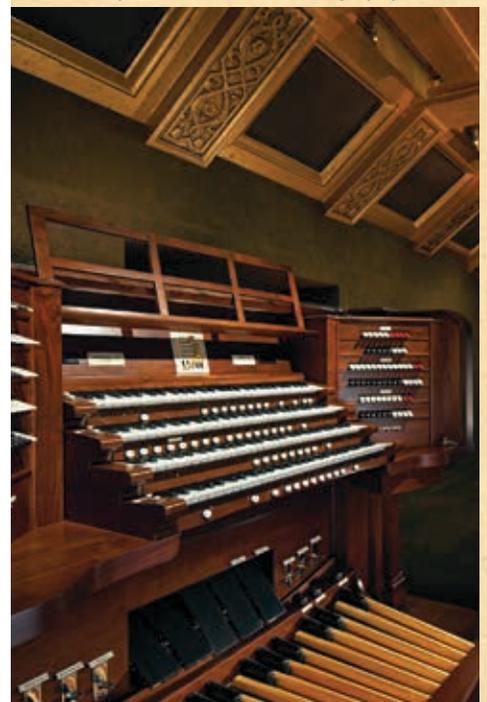
The organ was played for the first time after restoration on the eve of Rosh Hashanah, September 4, 2013. Photo courtesy of Tom Bonner Photography.

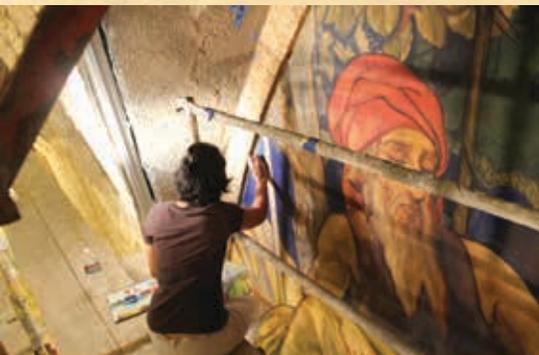
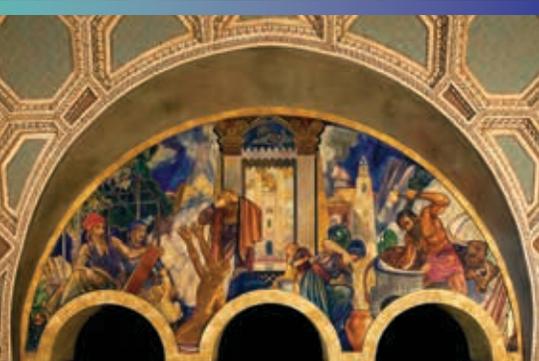
Restoration of Hugo Ballin's Warner Murals

Over the years, the murals' existing varnish aged and turned grayish-black or yellow dimming the vibrant colors. The paint was cracking into thin layers, and many of the panels were detached at the edges.

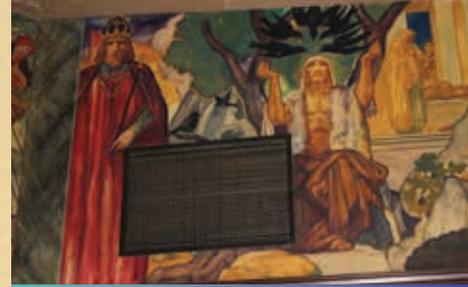
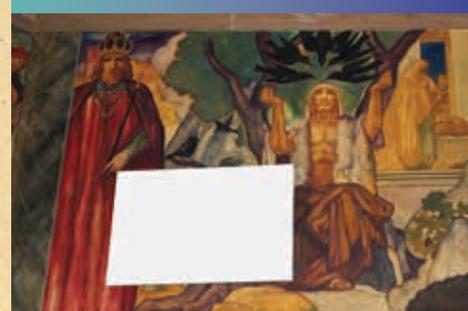
Conservators worked carefully to reattach lifting sections, repair cracks, and clean away dirt. Top photo courtesy of MATT Construction. Bottom photo courtesy of Tom Bonner Photography.

Conservators cleaned the surfaces with distilled water to remove dirt and salts. They repaired the canvas, reapplied and stabilized peeling gold and silver leaf, and coated the murals with a varnish that will allow future conservators to differentiate between the 2013 repairs and the original 1929 painting.

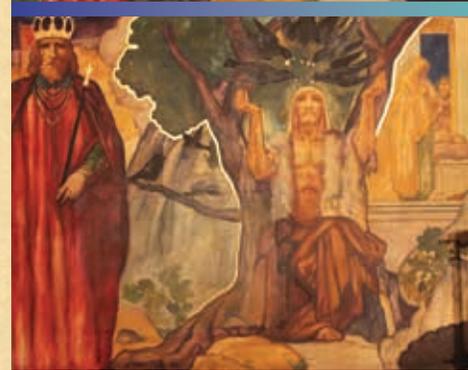
When old ventilation grilles were removed, conservators filled in sections of the mural to complement the original. Photos courtesy of Levin & Associates Architects.

One of the most interesting elements of the mural conservation was the infill of rectangular gaps left by old ventilation grilles. Once the grilles were removed and filled over by canvas matching the original thread count and color, the conservators had to “fill in the blanks.” They extrapolated from the surrounding images on the murals and painted the infill to match the original work.
